BLM Cedar City Field Office Site Inspection Report

May 1, 2015

To: BLM file UTU-72221 / DOGM S/001/0038
Anvil #1 & 2 Picasso Marble Quarry (expired notice)
Stephan Hodges

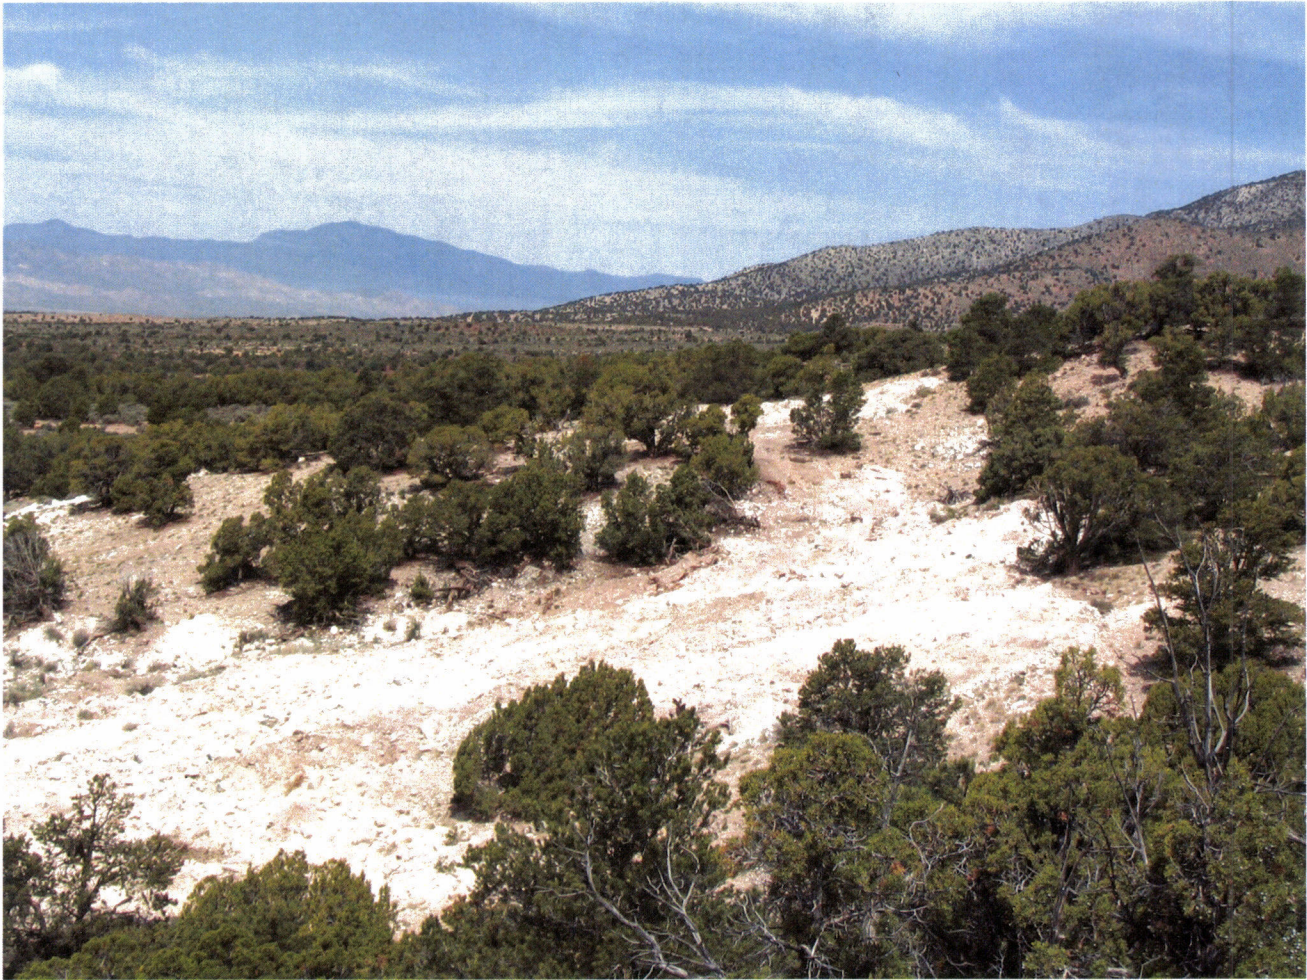
UTU-72221: Anvil
May 1, 2015

View of reclaimed project disturbances looking northwesterly from adjacent hillside.

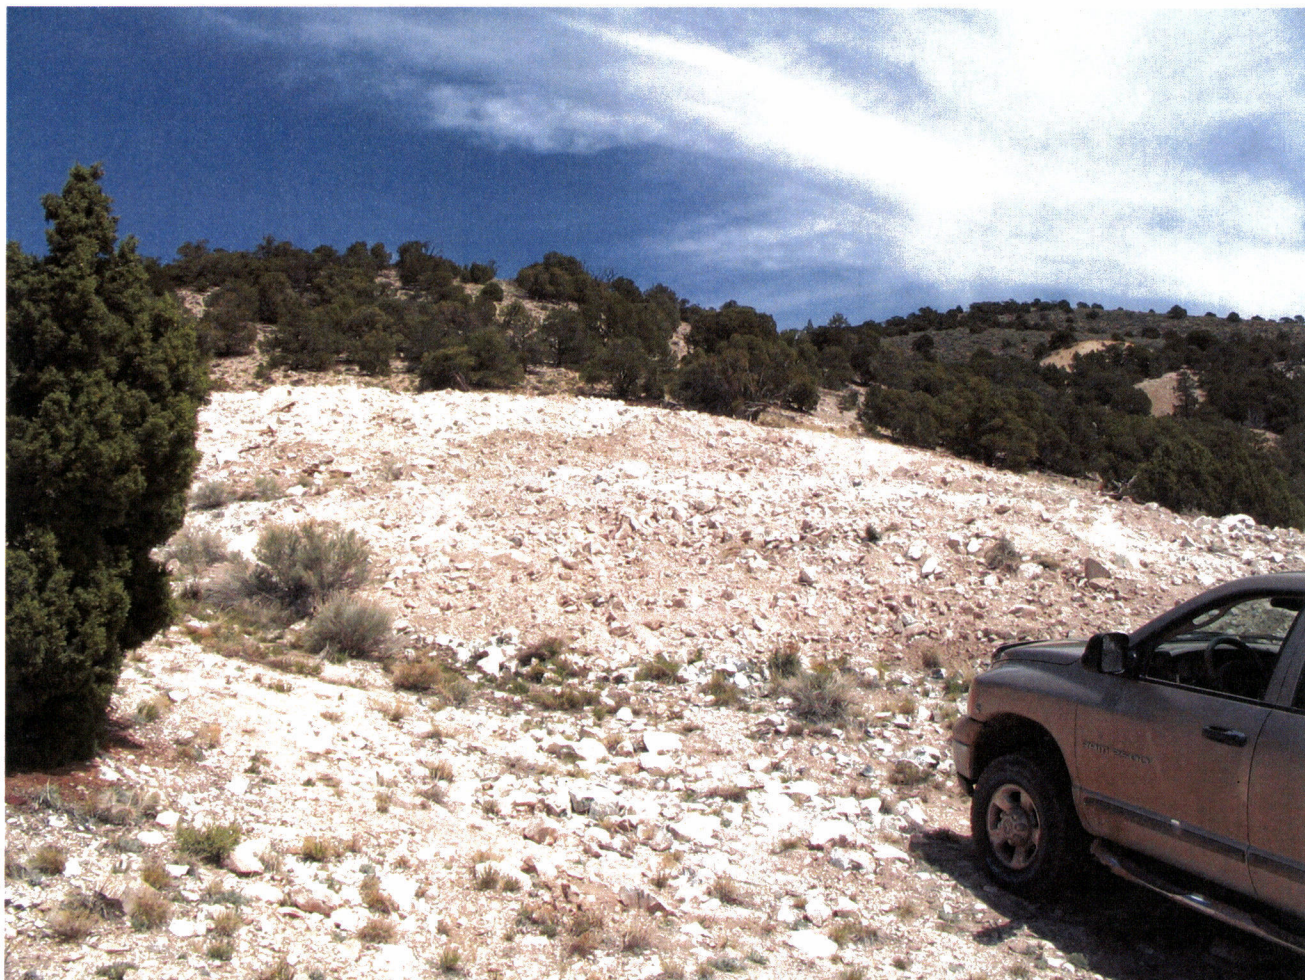
UTU-72221: Anvil
May 1, 2015

View of reclaimed project disturbances looking northeasterly from loadout.

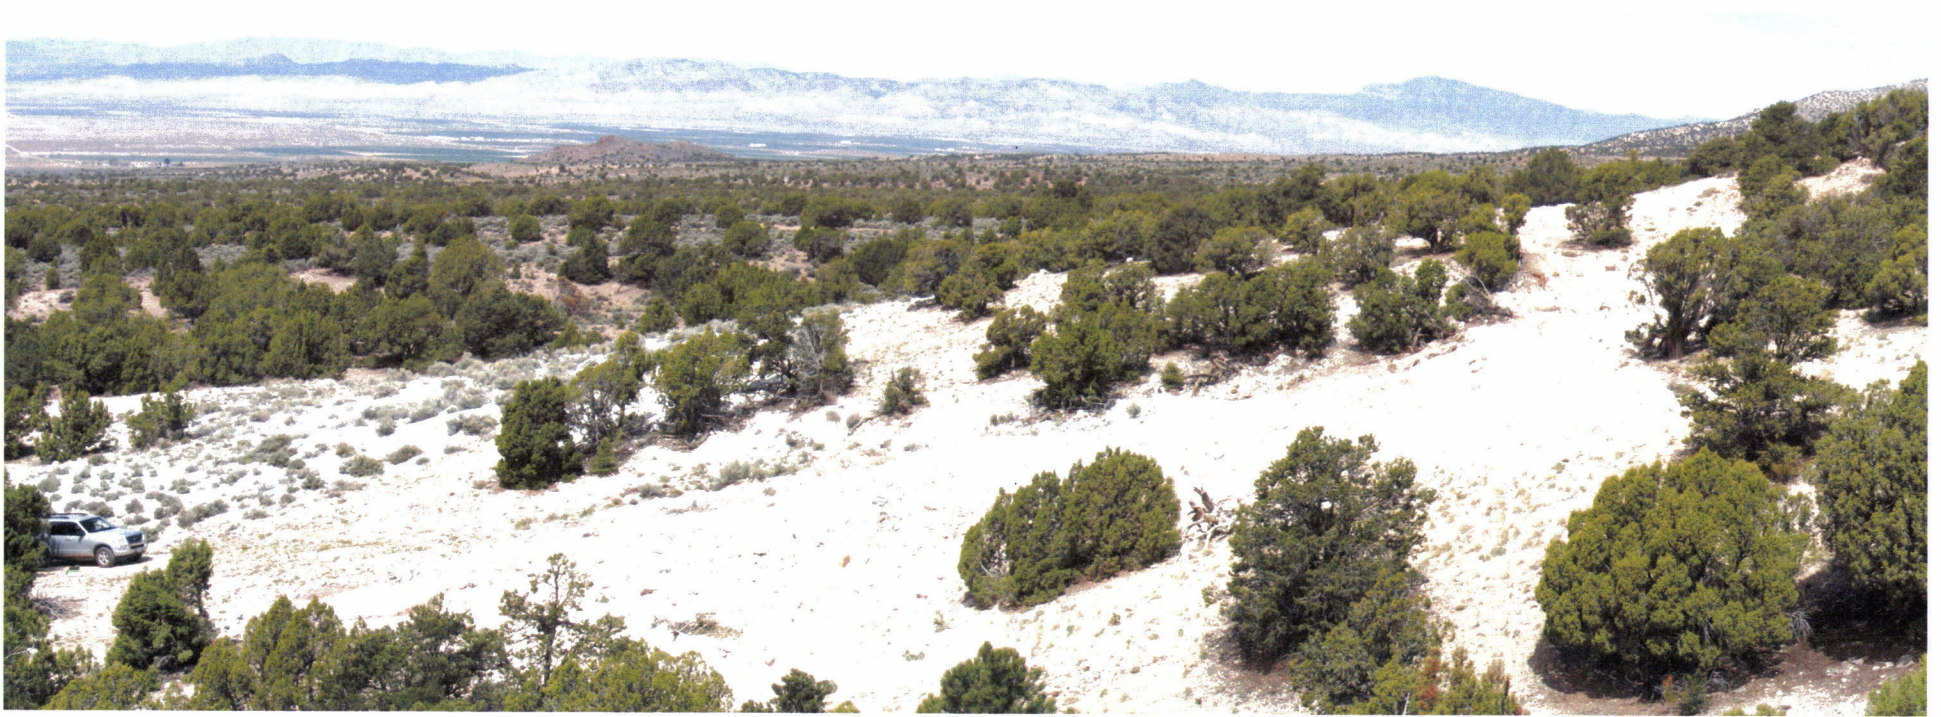
UTU-72221: Anvil
May 1, 2015

Panoramic view of reclaimed project disturbances looking west/northwest from adjacent hillside.

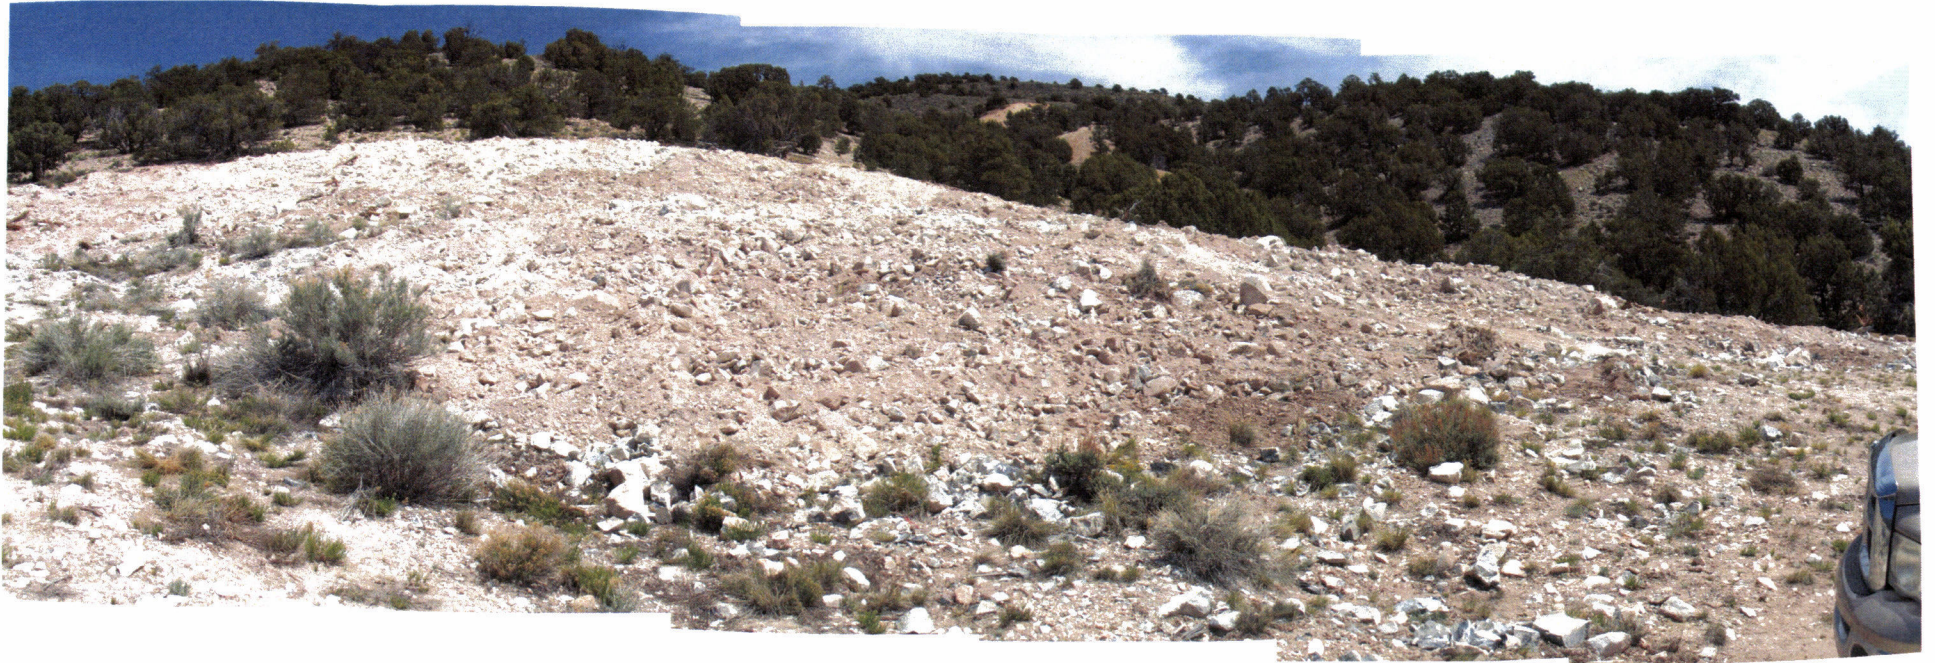
UTU-72221: Anvil
May 1, 2015

Panoramic view of reclaimed project disturbances looking northeasterly from the loadout area.
